PO Box 4949, Syracuse, NY 13221-4949  
OTISCO LAKE DAM REHABILITATION  
TOWN OF MARCELLUS  
SEPTEMBER 2015 UPDATE

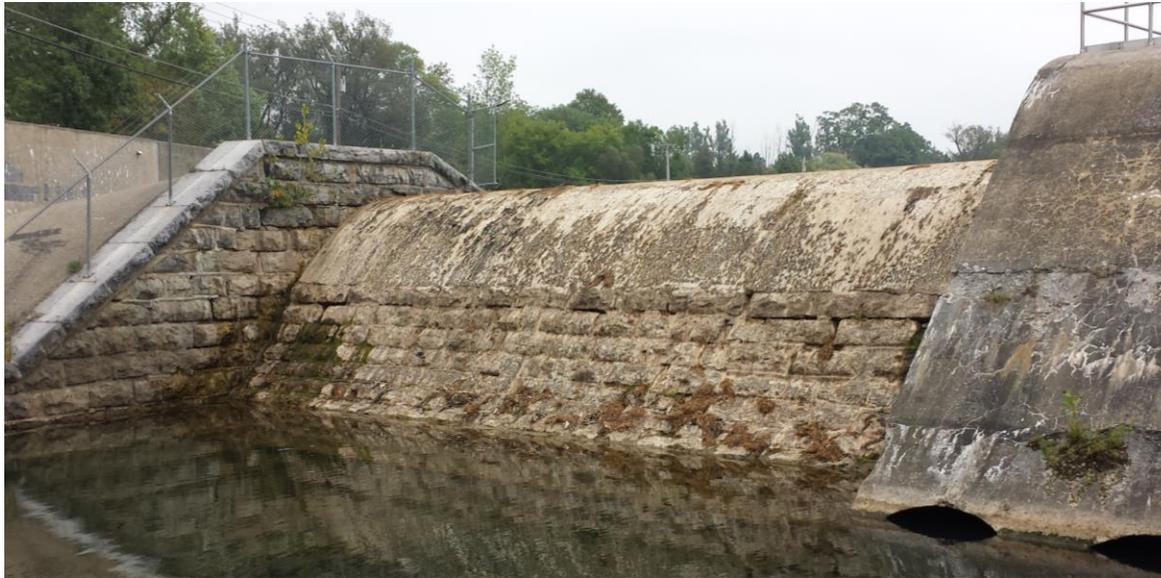
There have been many questions regarding the level of the lake during this work. We have provided a figure below that summarizes the historic lake levels and shows where we are now. In the previous article we mentioned that our goal was to be 12 to 18 inches below the spillway for the start of the project. As shown in the figure below, as of September 2, 2015 we are at 12 inches below the spillway, which is 6 inches above normal for this time of the year. This is adequate for the work and we have closed our gates down to the minimum for maintaining adequate flow in Nine Mile Creek. Based on the current level, here is what to expect for the next few months:

**Normal Weather:** If the weather for the fall is typical for Central NY, the lake level will continue to drop about 1 inch per week. This drop is normal for this time of year. You can see this in the figure below. Historically the lake reaches its lowest level each year in November.

**Very Dry Weather:** If we experience a drier than normal fall season, the lake may drop faster. The good news is that as of the beginning of September, we are actually about 6-inches higher than normal. This is shown by the yellow dot on the figure below. This should help avoid abnormally low lake levels even if the fall is very dry.

**Very Wet Weather:** If we experience a lot of rainfall, or a tropical storm or hurricane passes over the watershed, the level of the lake may actually rise. The rise in level is generally acceptable unless it reaches the top of the dam spillway. Experience has shown that very large storms can fill the lake faster than can be controlled. If that occurs, we will wait for the storm to pass and then will adjust the lake back to the target 12 to 18-inches below the spillway to allow to work to continue.
